Re: HPA APP ID #14829

Fish Ladder Monitoring Report for December 7th through December 13th, 2020

Fish Ladder Monitoring Report Checklist – HPA APP ID # 14829

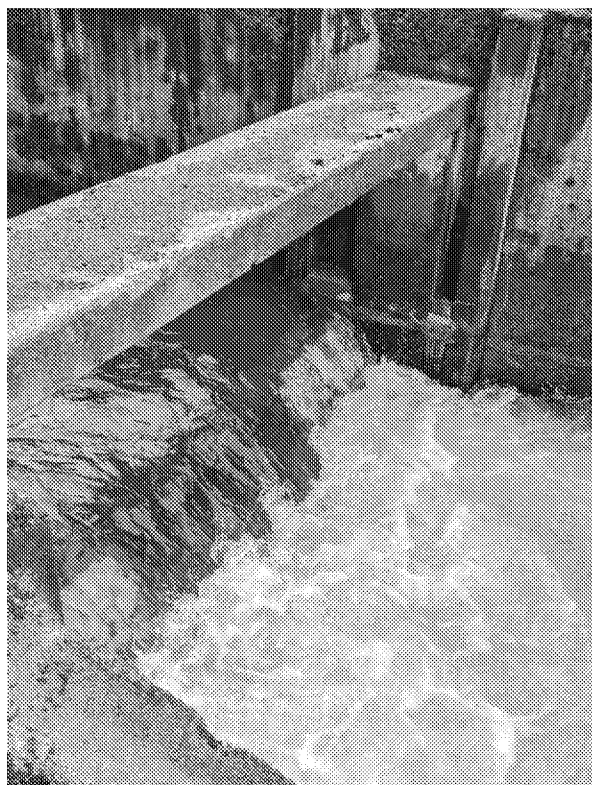
Photo 1: Ladder outflow on December 10th.

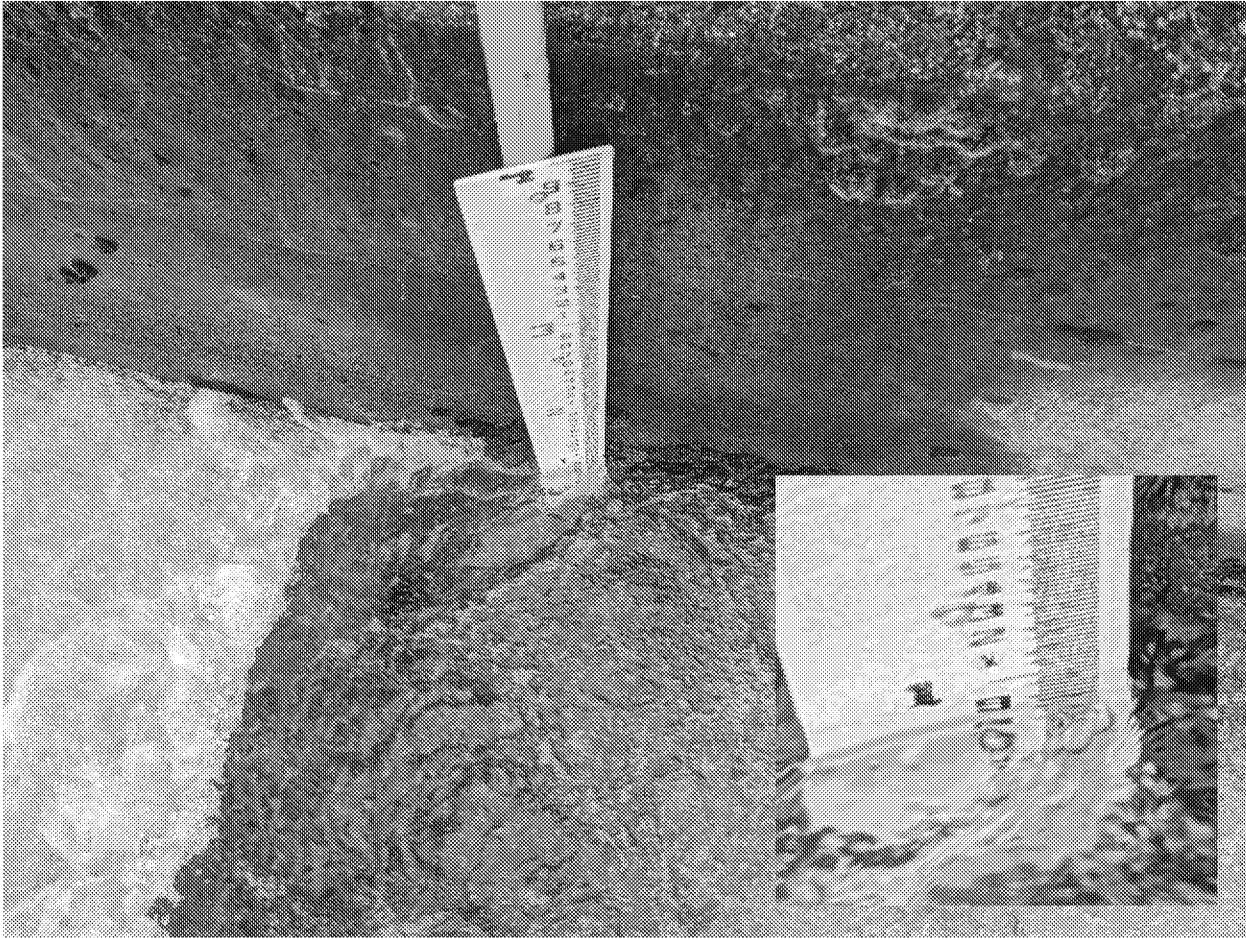
Photo 2: Staff gage measurement on top weir wall edge.
